**Final Report, Phase I
Sanitary Sewer Master Plan**

City of Waukesha, Wisconsin
September, 2011

Donohue & Associates

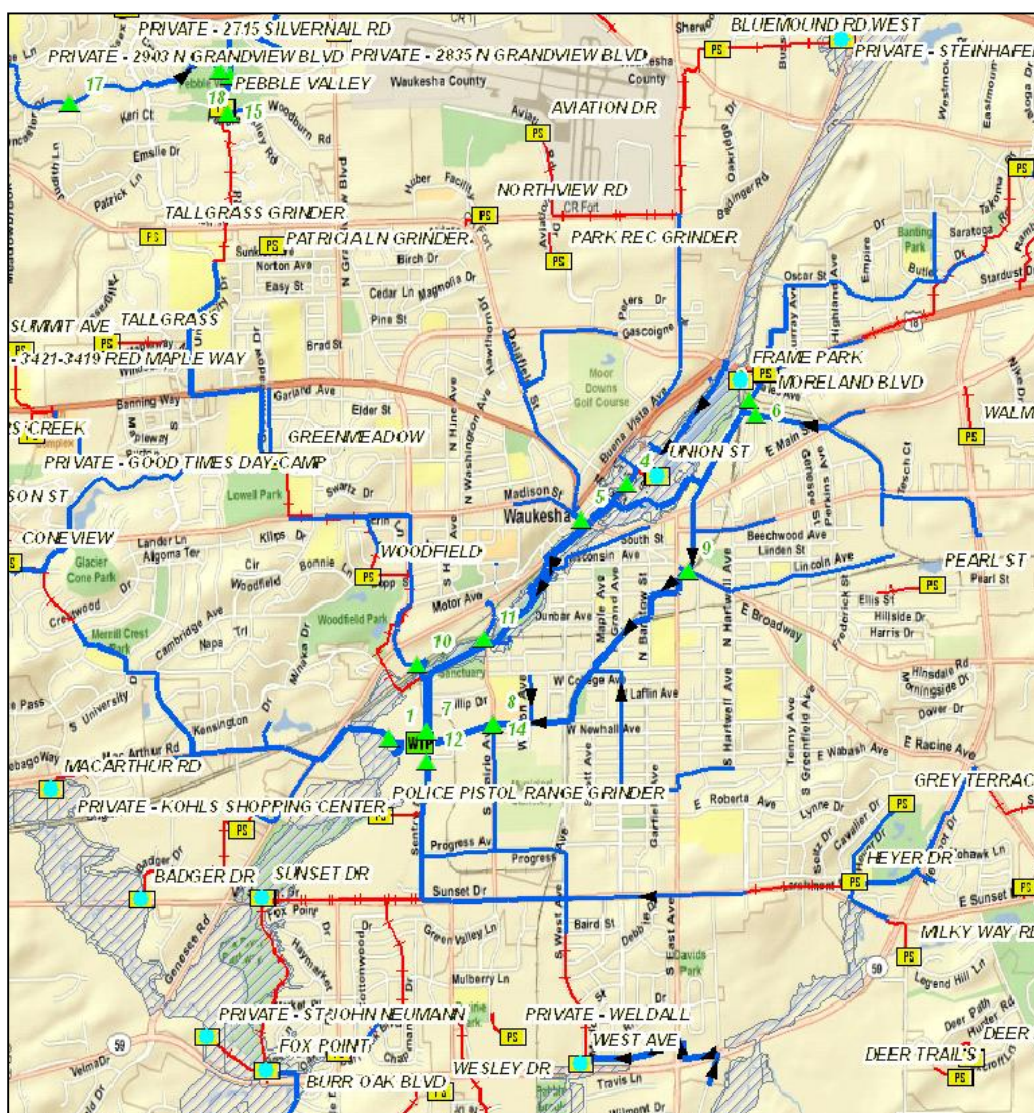
Figure 10 – Pump Stations within the 100-Year Floodplain

During large storm events, the Aviation Drive, Coneview, Pebble Valley, Summit Avenue, and Sunset Drive sanitary pump stations are at the greatest risk from flooding from stormwater runoff. The Sunset Drive, Fox Point, Badger Dr, Union St, MacArthur Road, West Ave, and Frame Park stations are within/adjacent to the 100-year floodplain. Appendix A contains detailed site plans for each of the recommendations in this chapter.

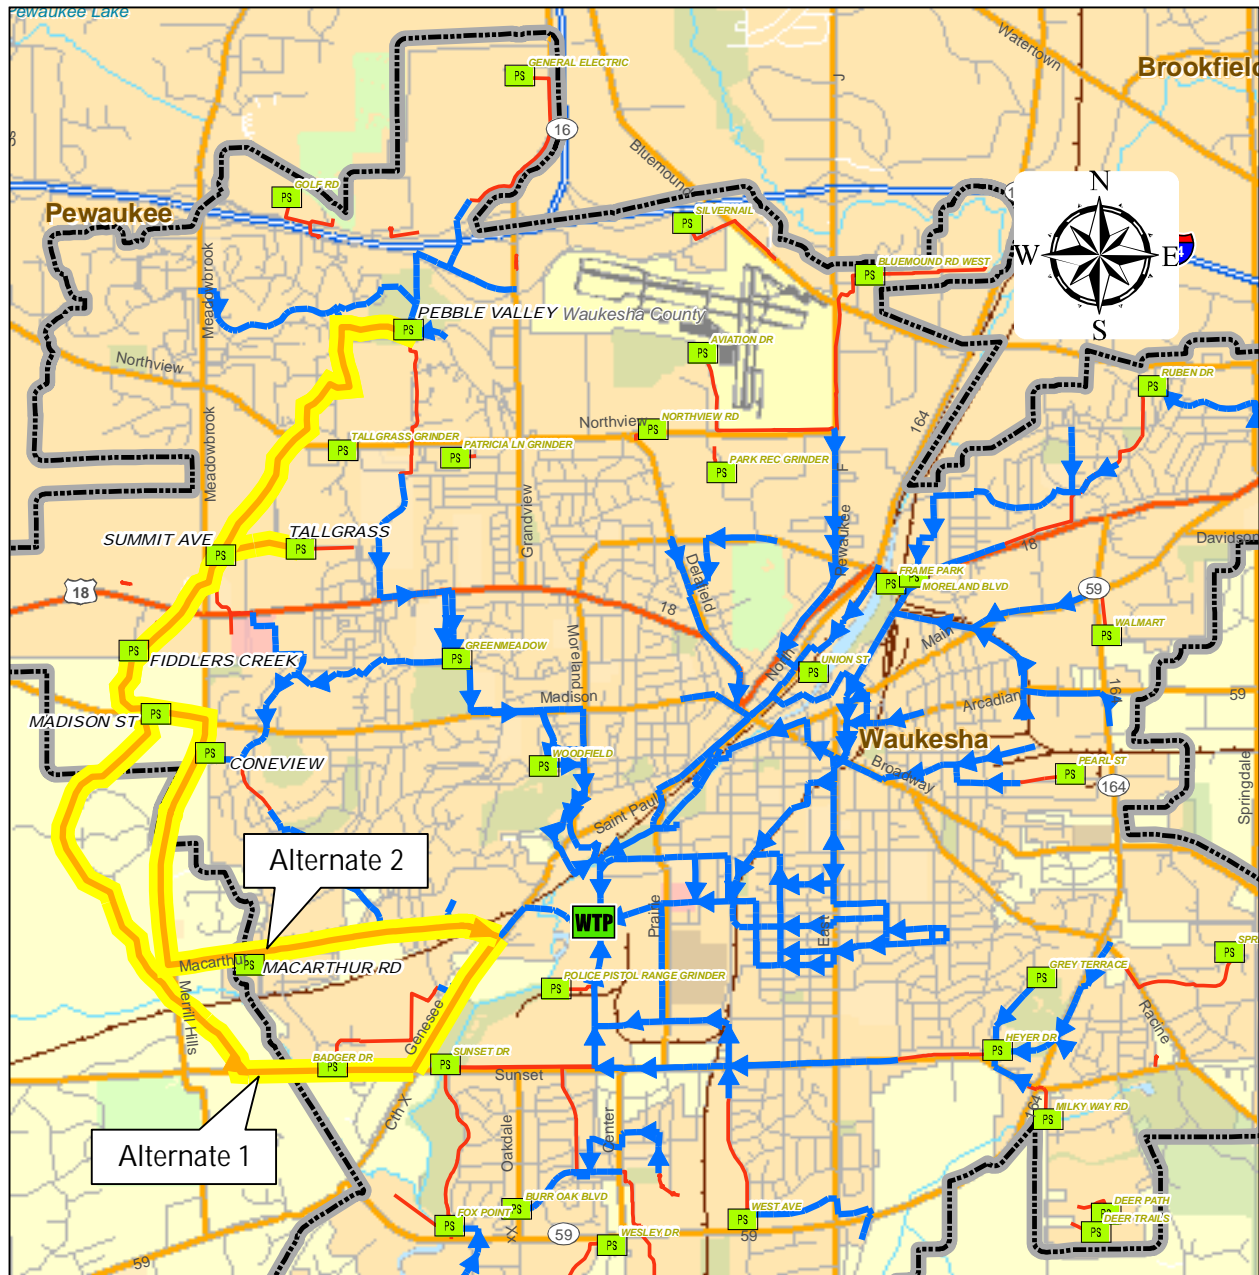
Figure 13 – West-Side Bypass Sewer

A gravity bypass sewer could potentially eliminate the following seven pump stations: Pebble Valley, Coneview, Heritage Hills, Fiddler's Creek, Summit, Tallgrass, and MacArthur Road. This sewer would be designed to match the capacities of the stations it replaces. Two possible routes are being considered for this bypass as indicated in Figure 13. Profiles of both routes have been included as Figure 14 through Figure 17. Note that the alternate route would be extremely deep, and would therefore require significant lengths of trenchless pipe installation. The design flow from Tallgrass was estimated and the pipe size was chosen to match the size of the existing influent pipe to the Tallgrass wet well.

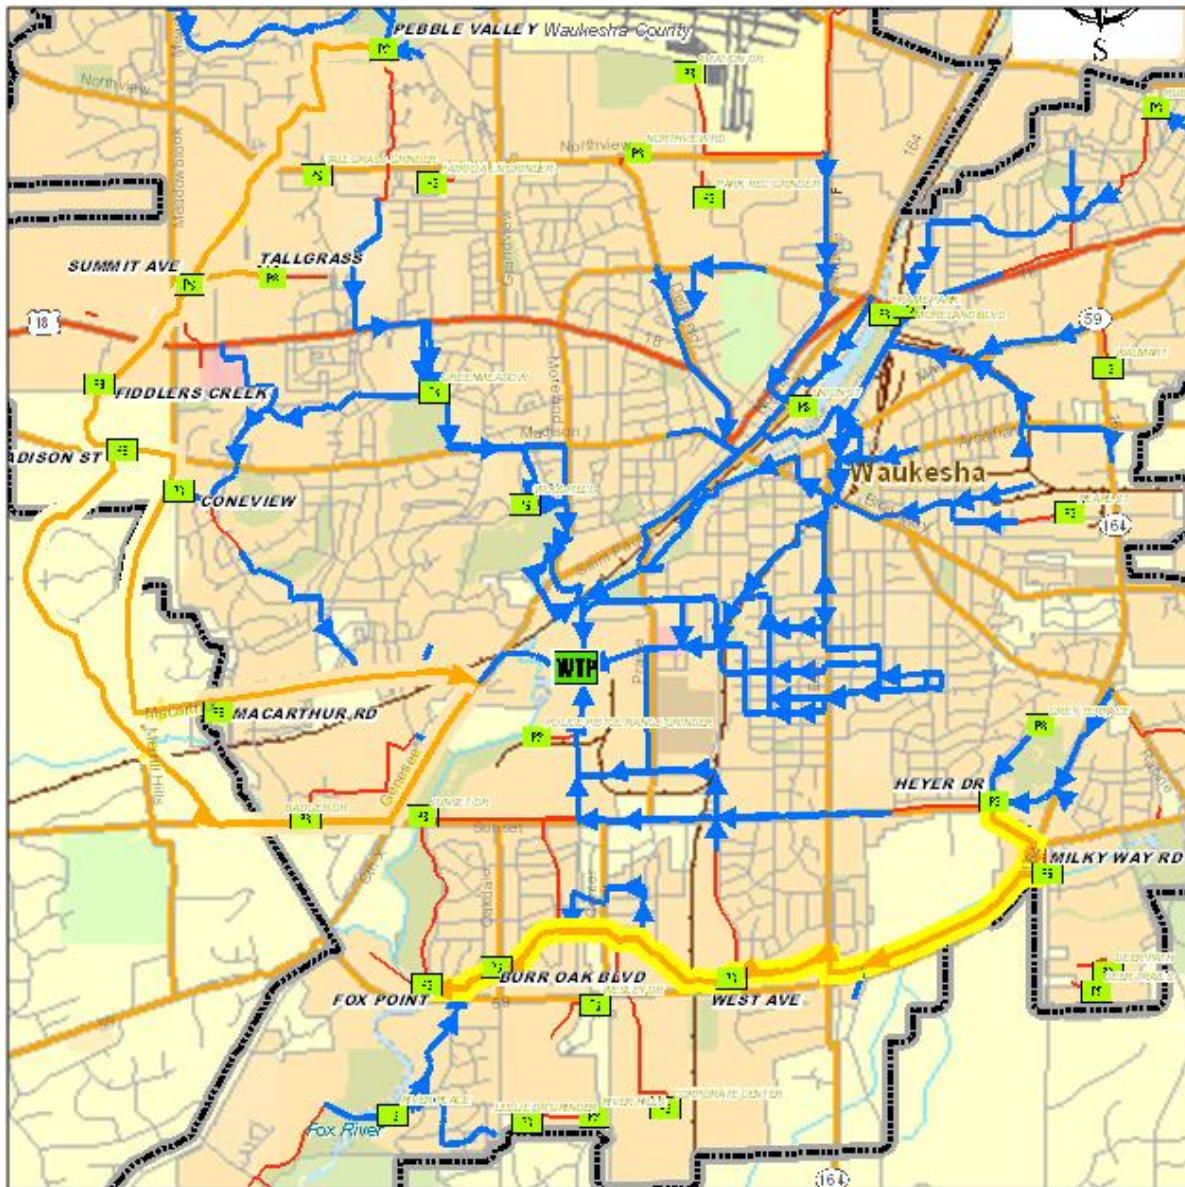
Figure 18 – Southeast Bypass Route

A second gravity sewer under consideration is the Southeast Bypass. This gravity sewer would eliminate the following four pump stations: Heyer Drive, West Avenue, Milky Way Road, and Burr Oak Blvd. The flow from these stations would be consolidated at what is currently the Fox Point pump station. This station and force main would have to be replaced to accommodate the additional flow. The proposed sewer route is indicated in Figure 18. Eliminating the Heyer Drive and West Ave force pump stations would eliminate the need for what have been two of the more problematic force mains. The estimated cost to design and construct this bypass sewer is \$6.85M. A detailed estimate of probable cost has been included (Table 6). This does not include the cost to replace the Fox Point pump station and force main.
